# Detail Master Home Inspections, LLC

**Home**  
5555 N. 23st Street  
Seamore, WA 98877

Thursday, November 18, 2004

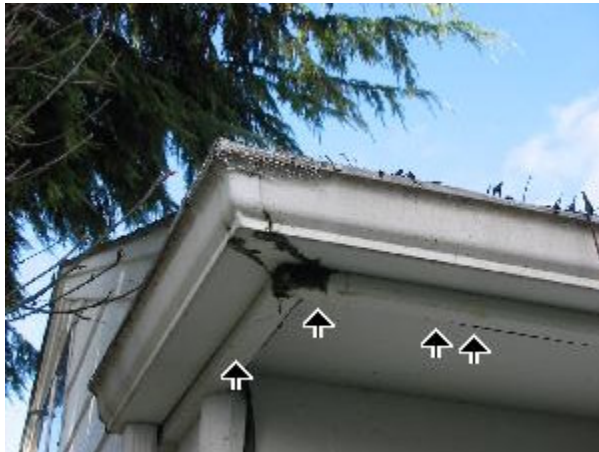
#### 1.0 SOFFIT, FASCIA, TRIM AND EAVES

**Comments:** Maintenance Repair/Replace  
Signs of excessive water contact to fascia and soffit. This wood is rotten in places.

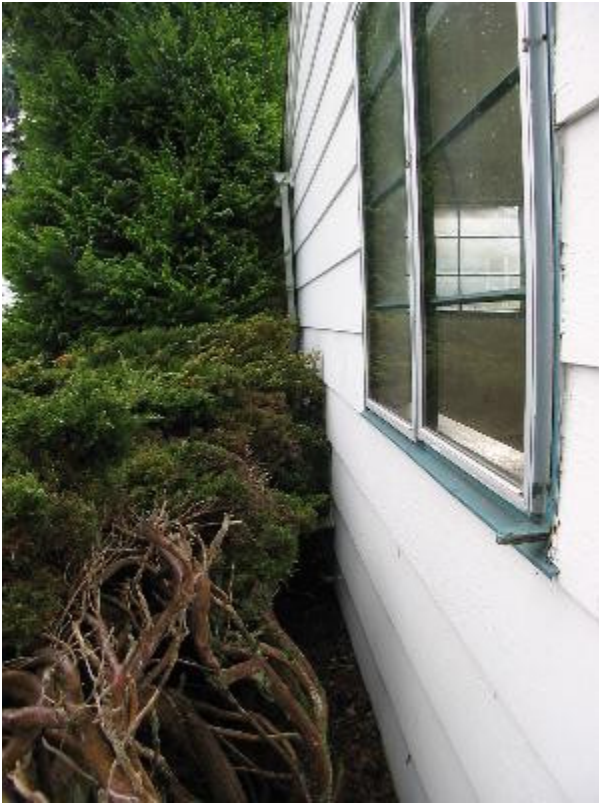
#### **1.11 OTHER DISCOVERIES**

Landscaping should be trimmed back at least 6 inches from house. Landscape contact conducive to pest infiltration.

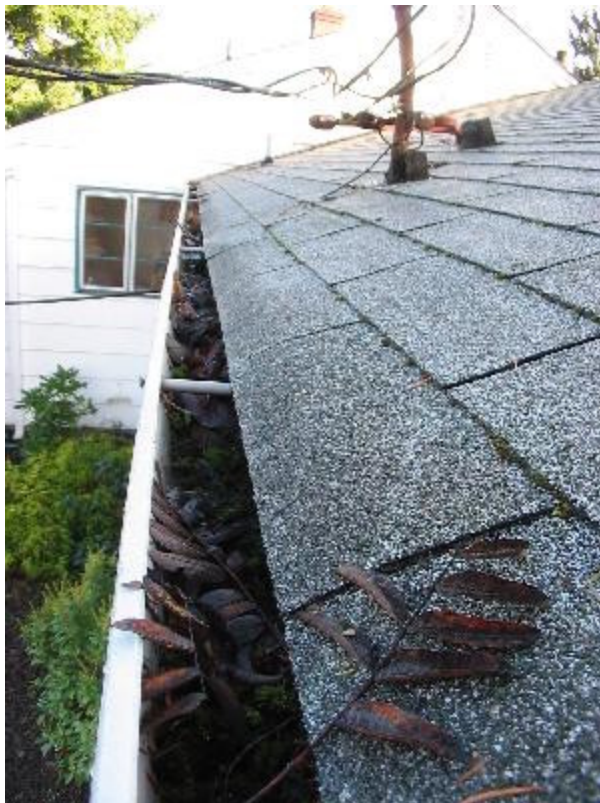
## 2.5 GUTTER DOWNSPOUTS AND DRAINAGE

Gutters and downspouts should be cleaned and checked annually to ensure proper function and flow. Down spouts rusted in areas and missing splash blocks that will help carry the water runoff away from the house and foundation.

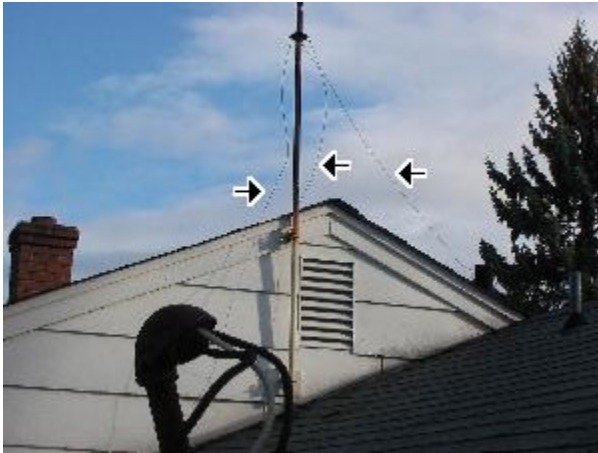
## 2.7 OTHER OBSERVATIONS

**Comments:** Inspected  
The antenna's support straps have been broken and antenna is not secured adequately now.

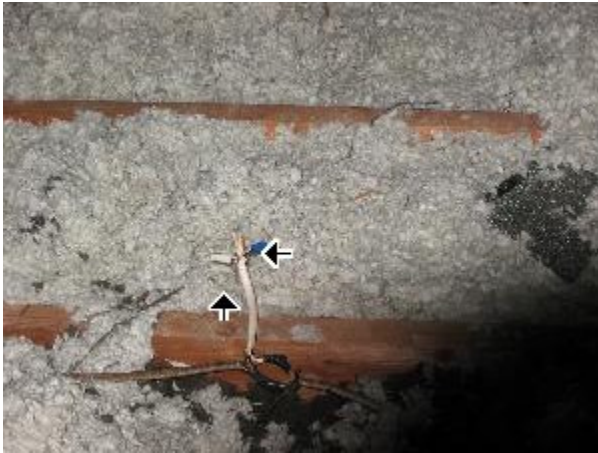
### 3.5 VISIBLE ELECTRICAL WIRING IN ATTIC

All wire splicing should be enclosed in a junction box and the wires should be secured to structural components. This is a fire hazard.

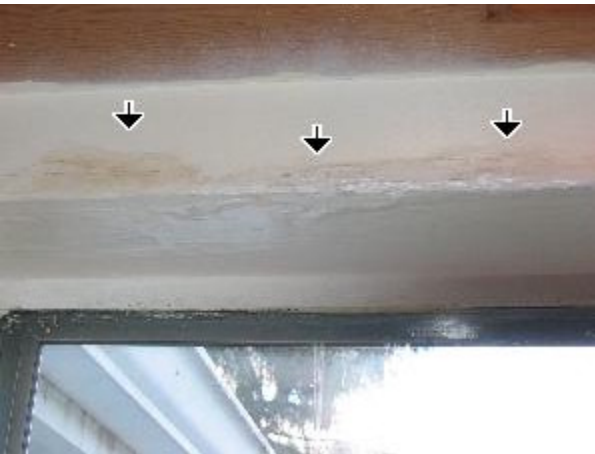
#### 4.6 WINDOWS

**Comments:** Inspected  
Kitchen sink window is inoperable. Wall above kitchen sink window has evidence of previous water damage.

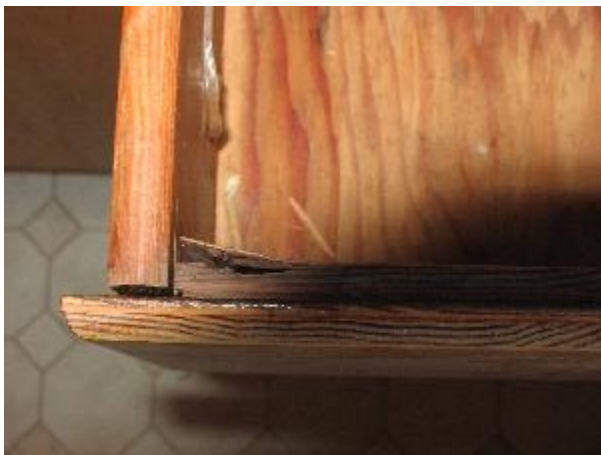
#### **4.16 CABINETS CONDITION**

Some damage to wood drawer on the far right side.

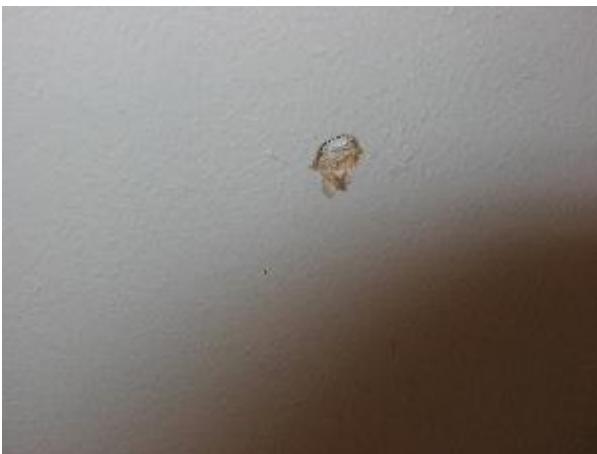
**5.2.B WALLS**

**Comments:** Inspected  
Dent present on the wall behind the door. Stopper installation behind the door would prevent further damage.

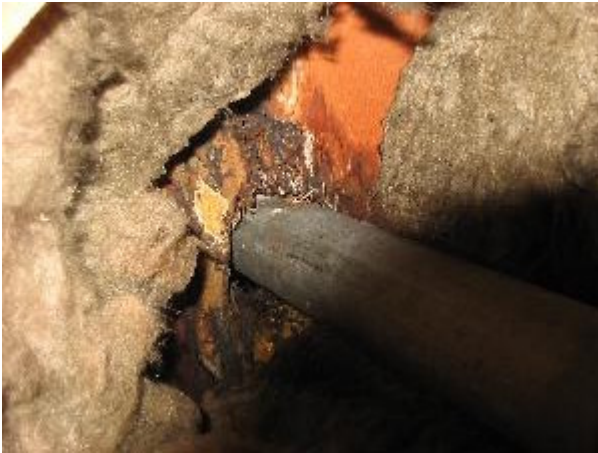
**5.3.B FLOORS**

**Comments:** Inspected  
When observing this area of the floor in the crawl space there is some wood rot around the plumbing pipes.

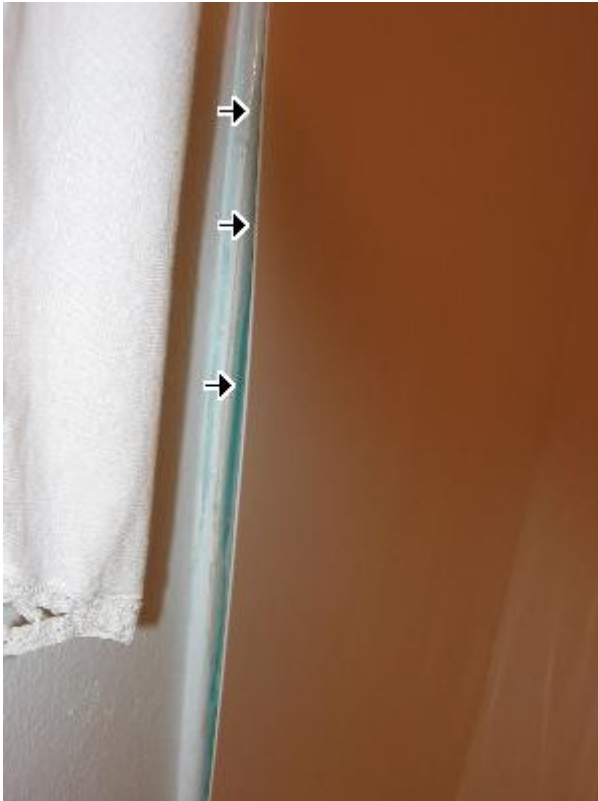
**5.17.B OTHER OBSERVATIONS**

The tub surround and base of the tub need to be caulked to secure it to the wall, possible water intrusion behind this surround. Tub surround is plastic laminate glued to ceramic tile. This is often a problem for leakage and does not show until major damage has occurred.

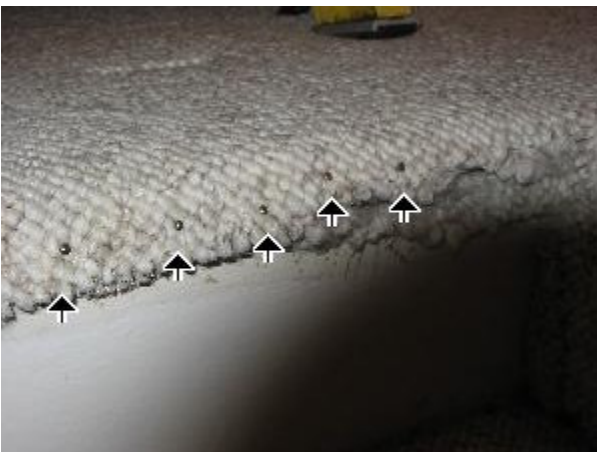
### 6.6.H STEPS, STAIRWAYS, BALCONIES AND RAILINGS

Carpet only secured to the stairs loosely with tacks.

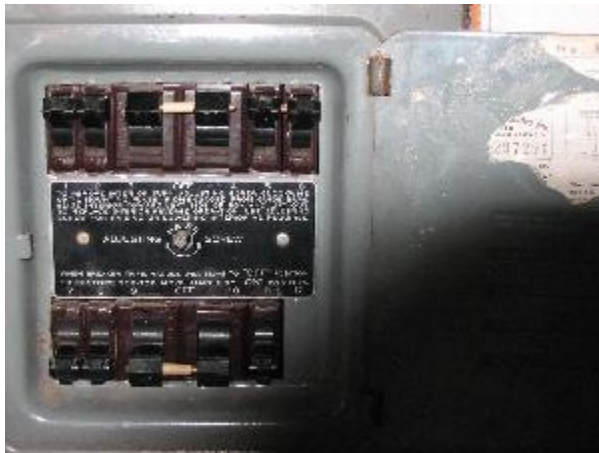
#### 7.2 CONDITION OF WIRING, CIRCUITS, OR FUSES INSIDE MAIN PANEL (Branch circuit conductors, Over-current devices, and compatibility of their amperage and voltage)

**Comments:** Maintenance Repair/Replace, Tradesman Repair/Replace  
Recommend having a trained electrician survey electrical system, label the panel, insure ground is present and make repairs to splices not in junction boxes at attic and crawlspace.

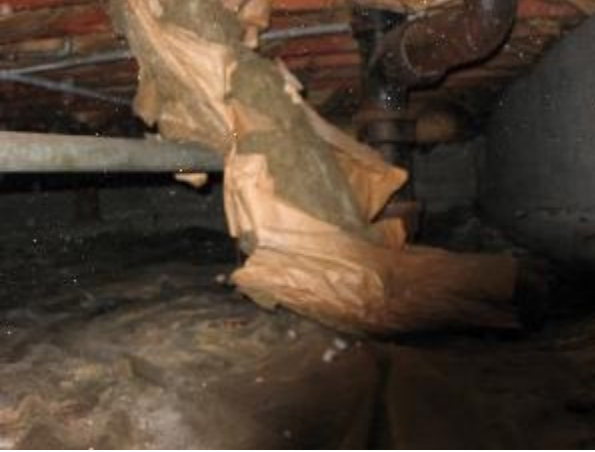
### 8.5 INSULATION OF FLOOR SYSTEM

**Comments:** Maintenance Repair/Replace  
Some insulation is hanging or fallen to the ground.

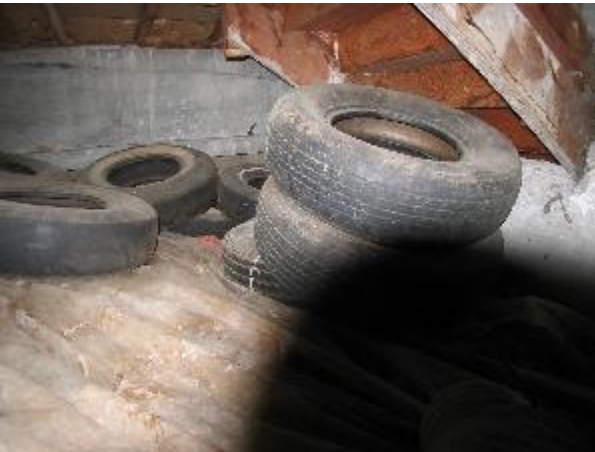
### 8.6 NOTE ANY DEBRIS IN THE BASEMENT OR CRAWLSPACE

**Comments:** Maintenance Repair/Replace  
Construction and garbage storage debris needs removing from crawlspace. This can be conducive to pest habitation.

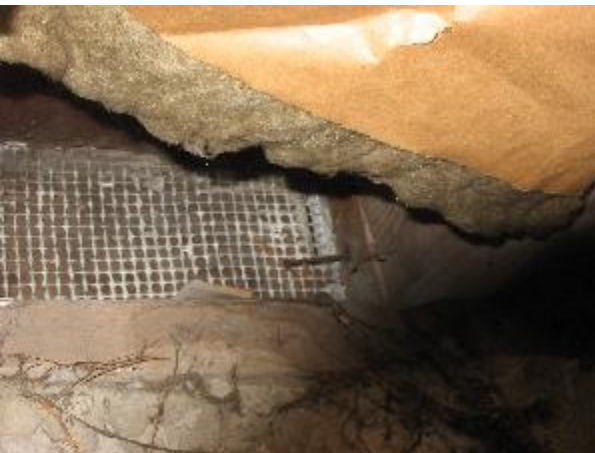
### 8.7 FOUNDATION VENTS OR WINDOWS

**Comments:** Maintenance Repair/Replace  
Insulation and other debris is blocking the vents and hurting the air circulation in the crawl space, this does not allow moisture to exit effectively.

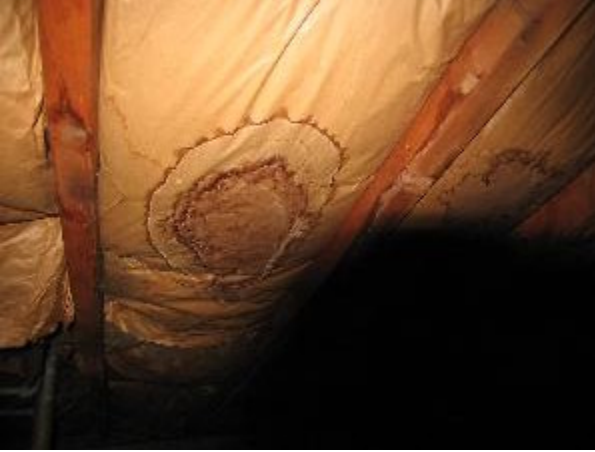
**8.8 REPORT ANY WATER INTRUSION SIGNS OR UNUSUALLY DAMP AREAS**

There is water damage present below the bathrooms and below the laundry room and stairs to the garage.

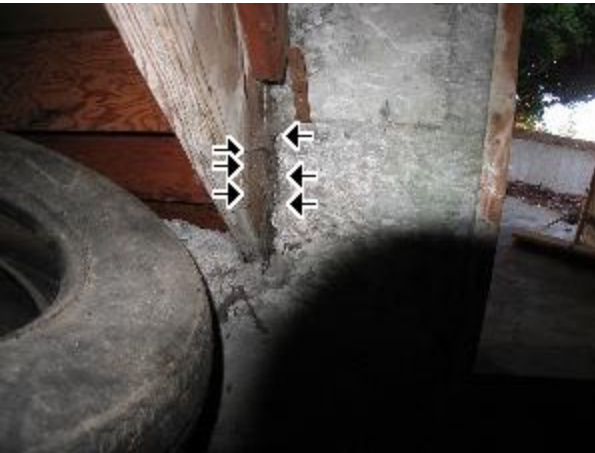
**8.9 OTHER OBSERVATIONS**

Holes on either side of the stairs are large enough to allow pests access to the crawl space from the garage. These holes need to be sealed.

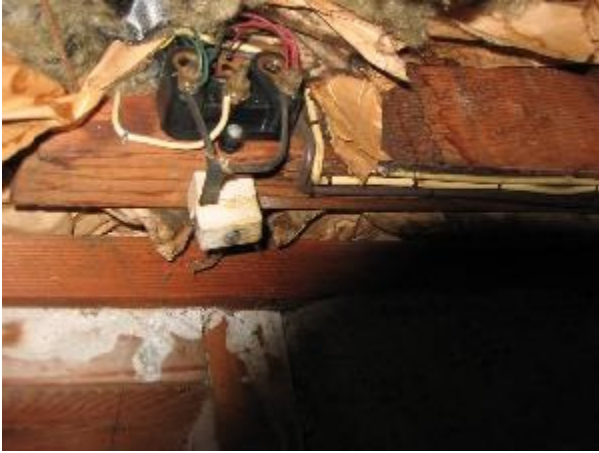
**8.11 OTHER OBSERVATIONS**

**Comments:** Maintenance Repair/Replace  
Open wire splicing in the crawl space, this must be in a junction box.

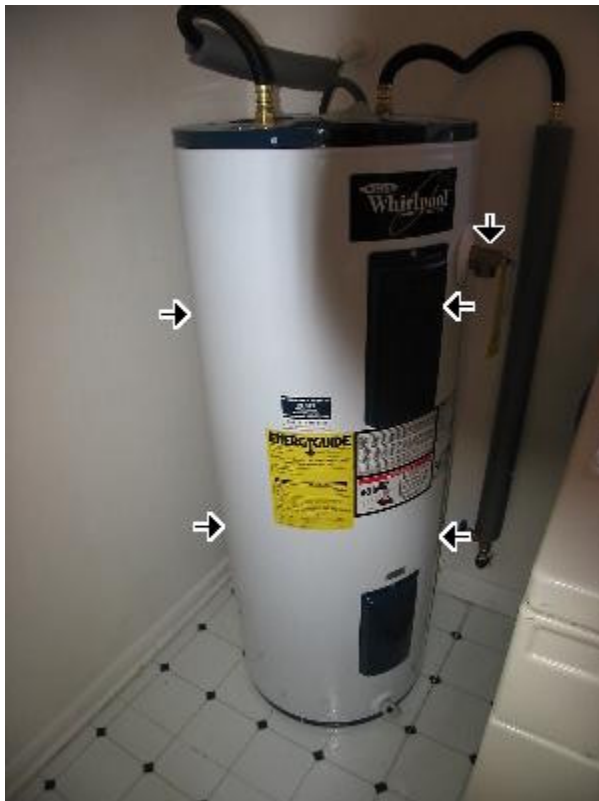
#### 9.3 WATER HEATER OR HOT WATER SYSTEMS

Seismic strapping recommended at top and bottom 1/3 of water tank, this will secure it to the wall.

T&P (Test and Pressure) valve on water heater needs a 3/4 threaded pipe to extend within 6 inches of floor for safety. (PVC is not approved for hot water use). Refer to the picture with the section above. Recommend placing water heater in a water basin to capture any excess water, and pipe this basin drain to the outside.

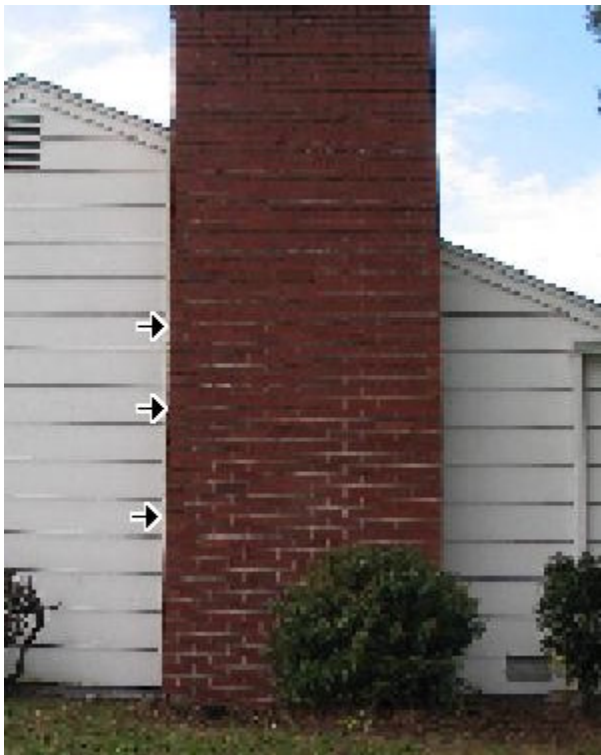
#### 12.6 OTHER OBSERVATIONS

Moss growth on the exterior portion of the chimney, this growth will loosen the brick mortar if not removed.
